# The Restoration of Frank Lloyd Wright's Fallingwater

Description: Provides an overview of the restoration of Frank Lloyd Wright's Fallingwater, including details regarding structural issues, moisture intrusion, roof and terrace restoration, and interior and exterior coatings.

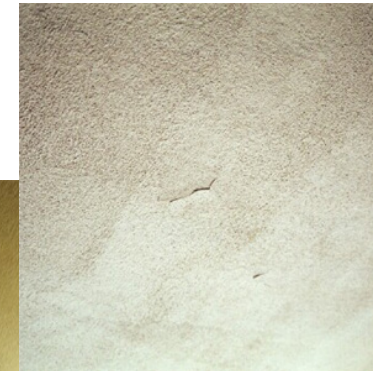
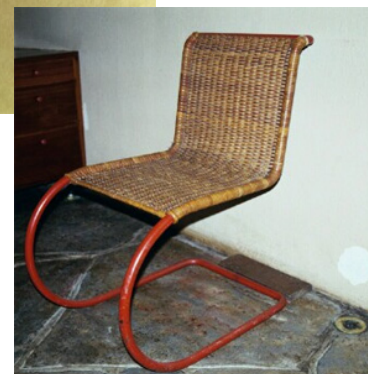
- Even before the family moved in to Fallingwater, Edgar Kaufmann noticed cracks appearing in the east and west parapets of the terrace for the main bedroom.
- Over the years Kaufmann had his engineers monitor the angle of the cantilevers after it became obvious that they rose and fell in response to seasonal temperature changes.
- This constant movement resulted in cracks, which were treated with an occasional cosmetic patching and repainted without addressing the underlying structural issues.

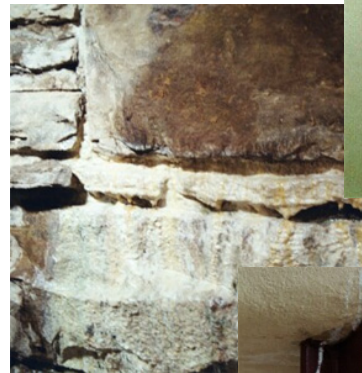
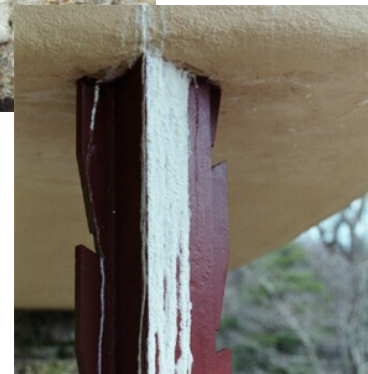
- Other problematic areas included the discovery of stalactites and carbonate lines in the soffits below the terraces and near drains, and the sodden lumber and insulation beneath roof and terrace flooring.
- The parapet walls were also of concern. Even Wright believed they were not as effective in carrying the load as had been anticipated.
- From the outset, engineers who were independently contracted by Kaufman expressed doubts about the structure and believed it would eventually break apart.

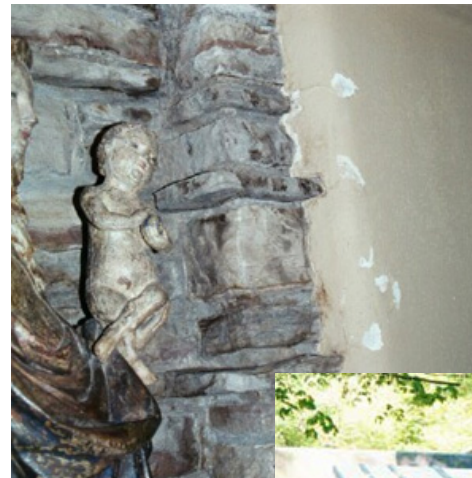
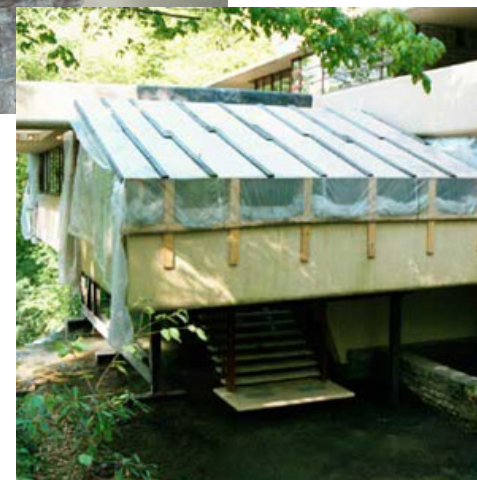
- In the interior of the structure, warped doors, peeling paint, stains and cracks also appeared as a result of structural deficiencies involving the cantilevers.
- "As in any building, maintenance is a constant issue at Fallingwater" says Lynda Waggoner, VP of the Western Pennsylvania Conservancy and Director of Fallingwater.
- The current 11.8 million dollar renovation demonstrates the need for a distinction between routine maintenance and restoration / renovation / preservation efforts.

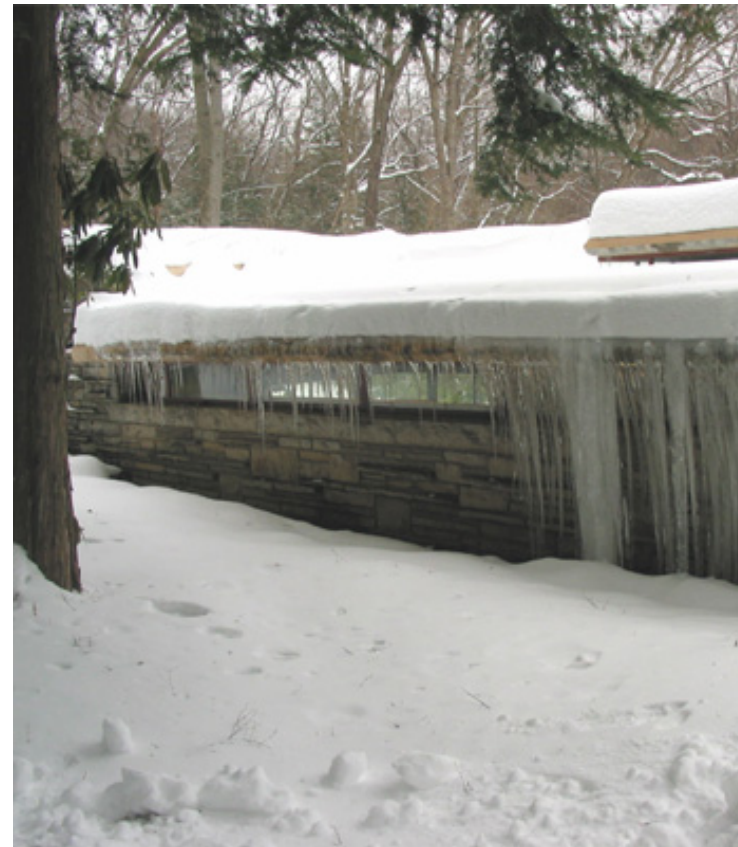
- In addition to roofs and terraces that incorporated parapet walls, a report cited Fallingwater's rounded roof edges as one area of considerable moisture penetration.
- The rounded roof edges did not provide adequate drainage at the roof roll, causing moisture to migrate from the underside of the concrete roof slab and under the waterproofing membrane.
- It was concluded that the roof and ceiling assembly worked like a sponge: it soaked up moisture, allowed it to collect under the roof membrane and eventually migrate through to the ceiling.

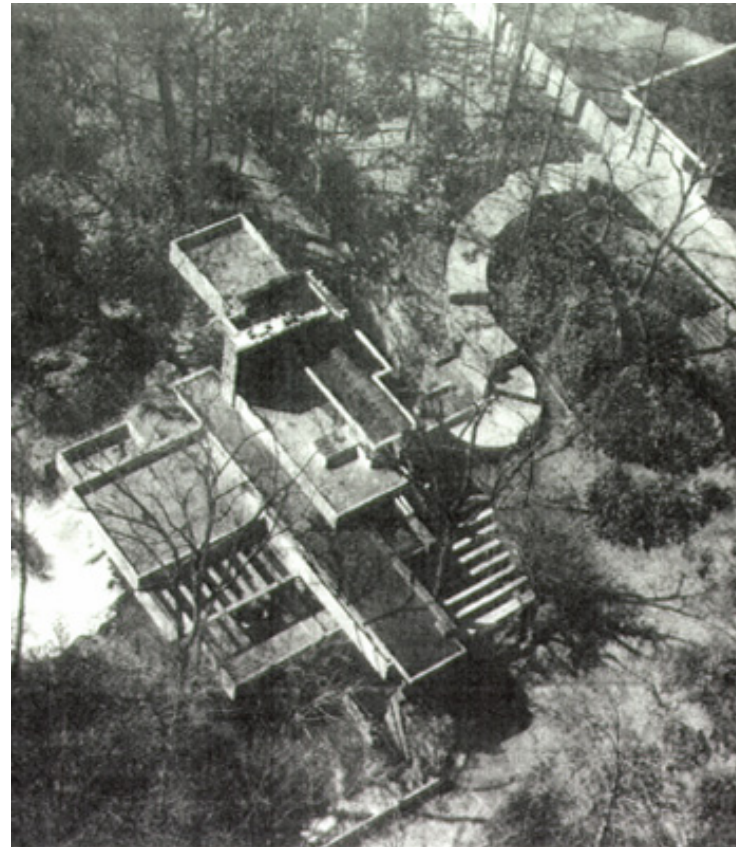
Photo from APT Bulletin, Volume XXXII, Number 4

- In the design pathology of Fallingwater, it was also observed that the property's plan resembled a pinwheel with terrace arms that extended outwards.
- These horizontal exposures created a much greater chance of moisture penetration from rain, melting snow, humidity and the general failure of waterproofing and roof system assemblies.
- Fallingwater reminds us that designing the building envelope for watertight integrity requires scientific analysis of the physical properties of materials and the compatibility of assemblies in relation to the forces of nature.

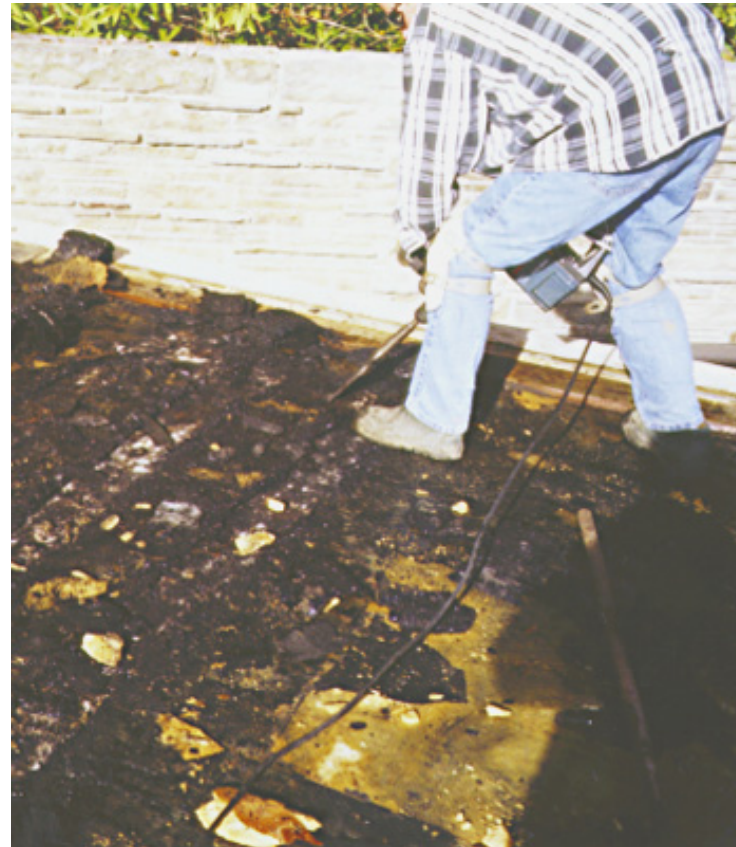
- To help control moisture intrusion and damage, a new roofing system was devised. A Pittsburgh roofing company was brought in to tear off the existing roof and apply the new system.
- While tearing off the existing roof system, contractors made several noteworthy discoveries. For example, some of the lighting fixtures had been installed directly under the roofing membrane.
- Roofing contractors also found that no flashings or interior drains had been incorporated into the roof design. Virtually all of the roof materials removed were wet.

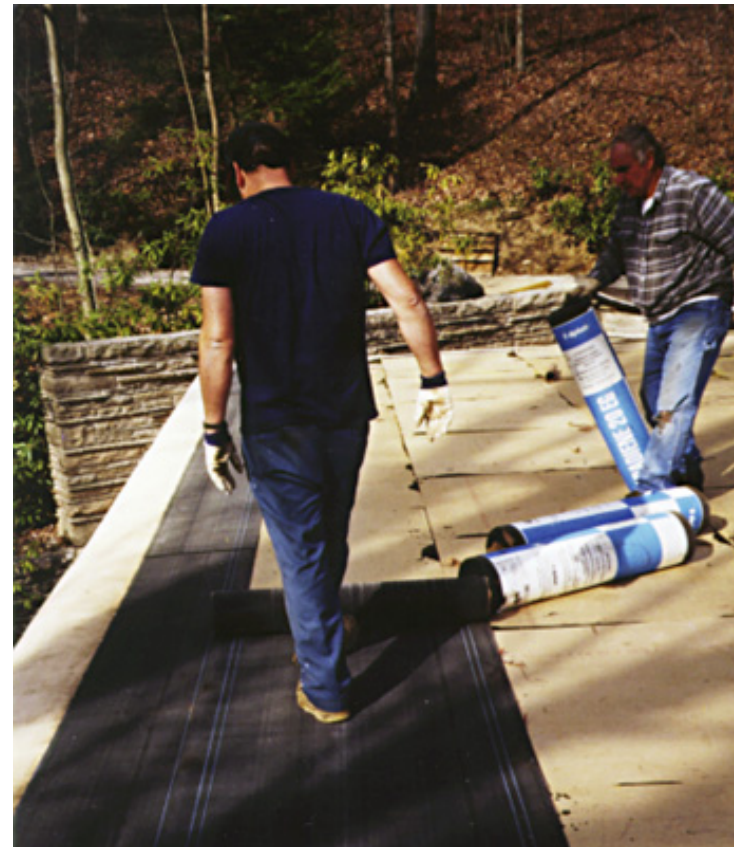
1. A venting base sheet is torch applied over the primed concrete slab. This base sheet is a modified bitumen ply with a series of modified asphalt stripes, which bond to the concrete slab and provide venting channels to disperse any vapor pressure.
2. Rigid fiberglass insulation boards are then laid in asphalt and placed over the venting base sheet. The original specification called for an organic insulation but the contractor firmly believed the moisture concerns of Fallingwater would be better served with fiberglass rigid board insulation.

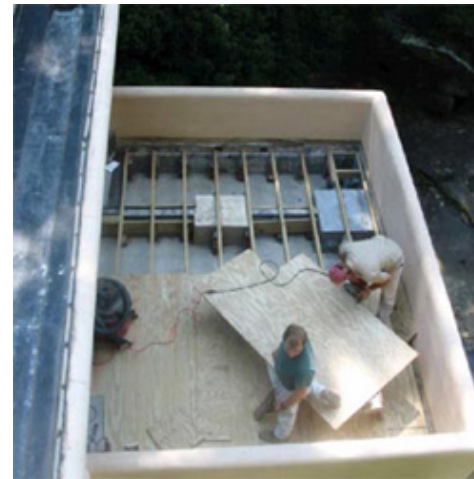
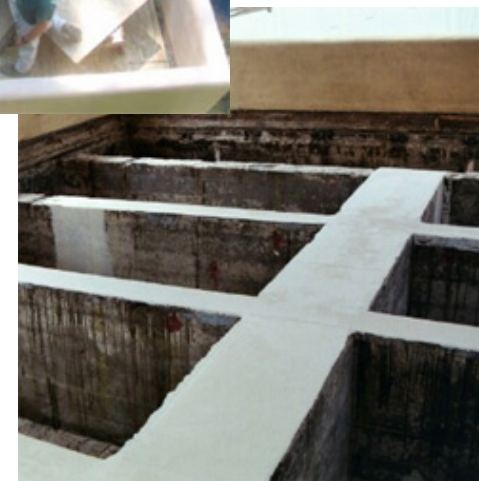
- Terrace slabs were originally constructed either as exterior floors or as ceilings with other interior living spaces below.
- The terraces that functioned as floors consisted of concrete decks with parapet walls for additional support. The parapets also added rigidity to the horizontal planes.
- The terraces that functioned as ceilings consisted of wood decks and flagstone raised above the floor slab by deep ribbed concrete support beams. The air space between the slab and the wood decking acted as insulation.

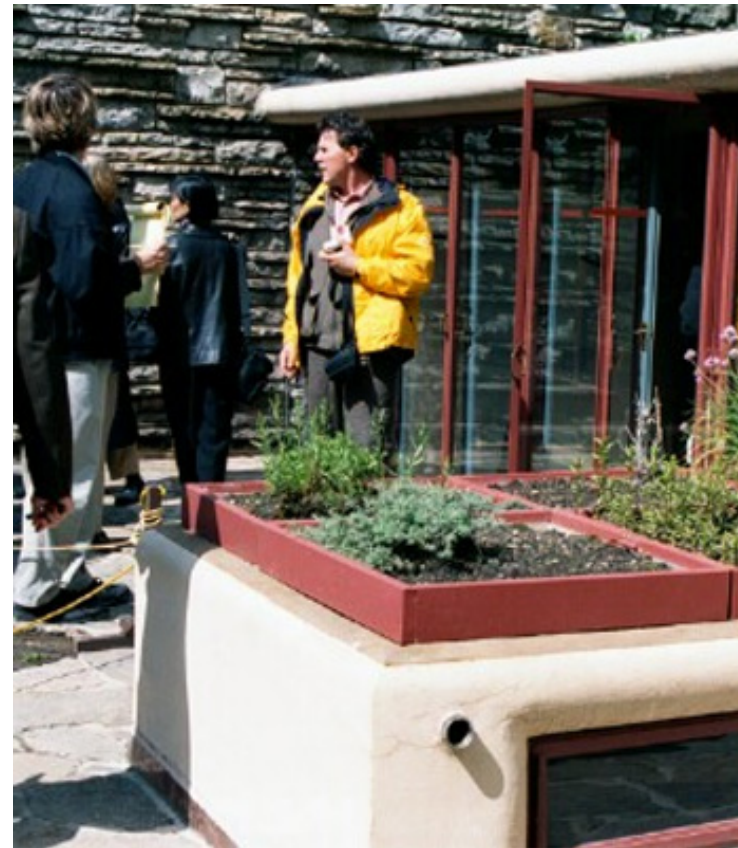
- In 2001, a new waterproofing system was installed at the Herb Terrace, however its design created a number of problems.
- Because the filter fabric around the drain was too fine and the drains were not set lower than the deck, water was able to get under the drainage mat, causing the entire overburden to float.
- Also, the needle punched fabric of the drainage mat allowed for flexing, resulting in a sort of trampoline effect. This, combined with the sand bed, lead to the rocking of the flagstones and the cracking of the grout joints.

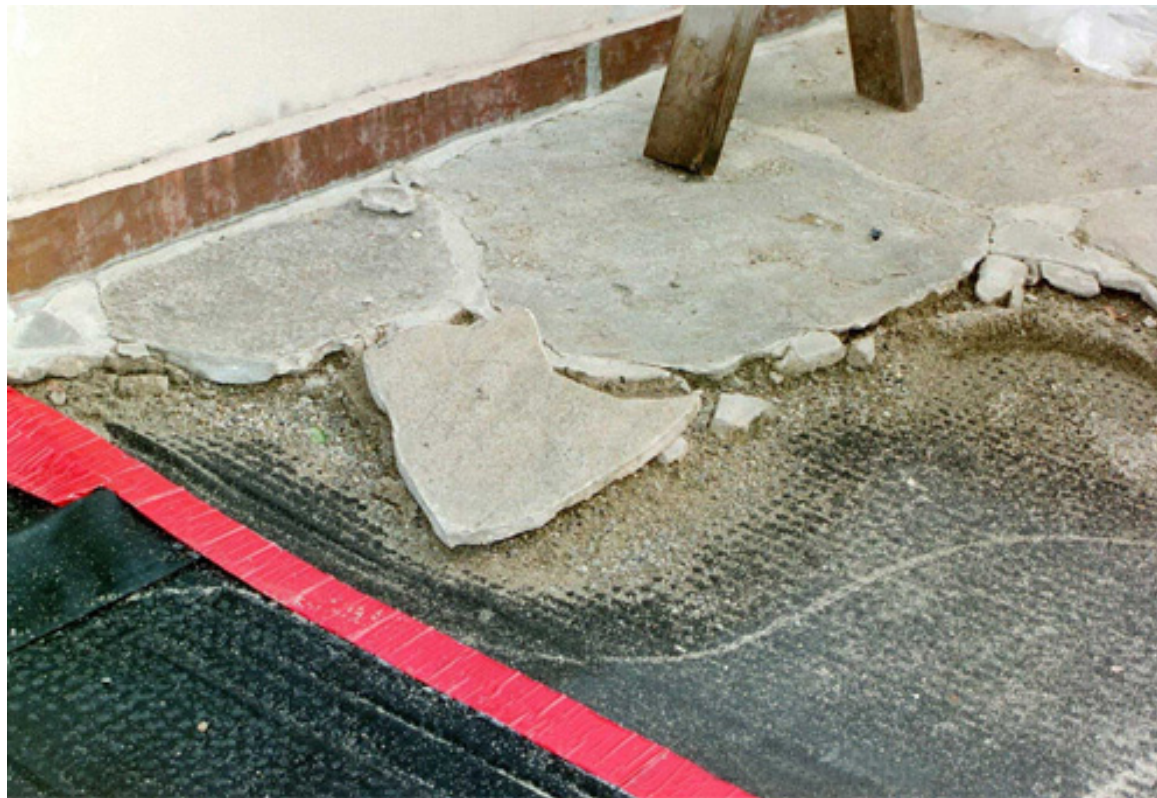
Terrace restoration began with removal of the flagstone. Stone masons photographed, mapped, and numbered each stone for removal.

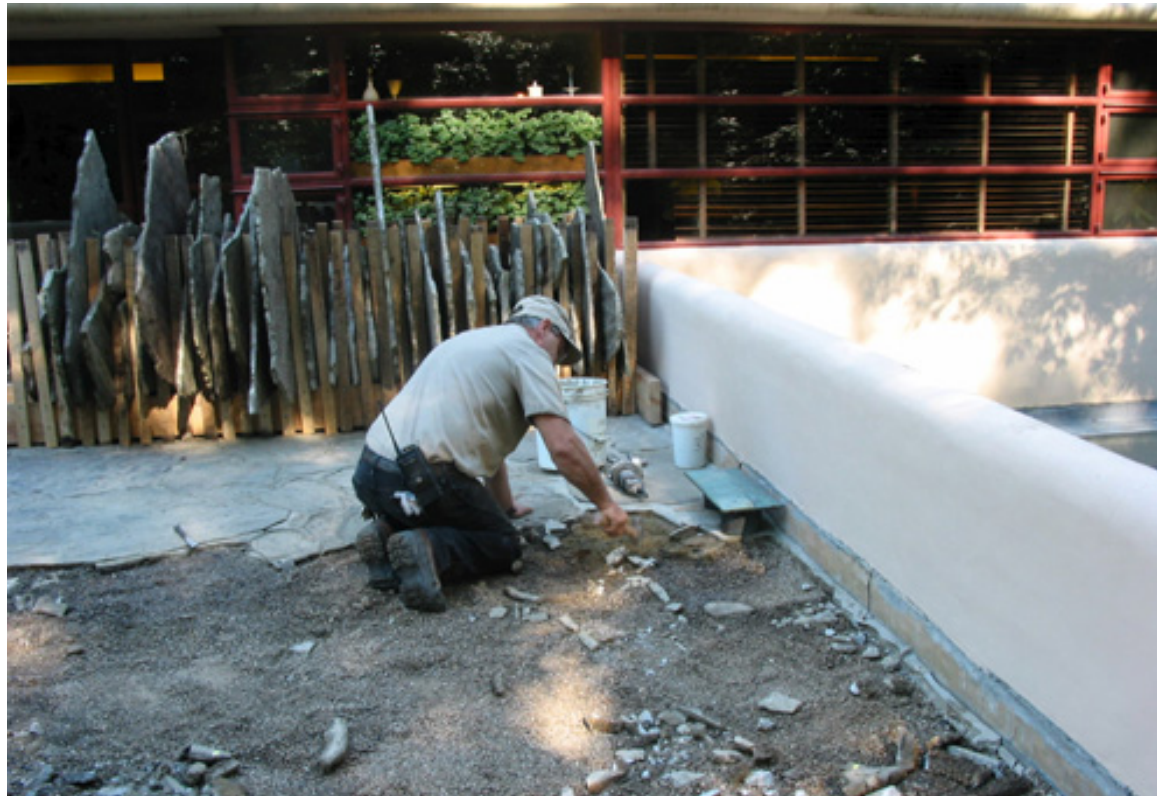
They carefully chipped away the grout and pried up each stone, which was then removed and vertically stored on pallets.

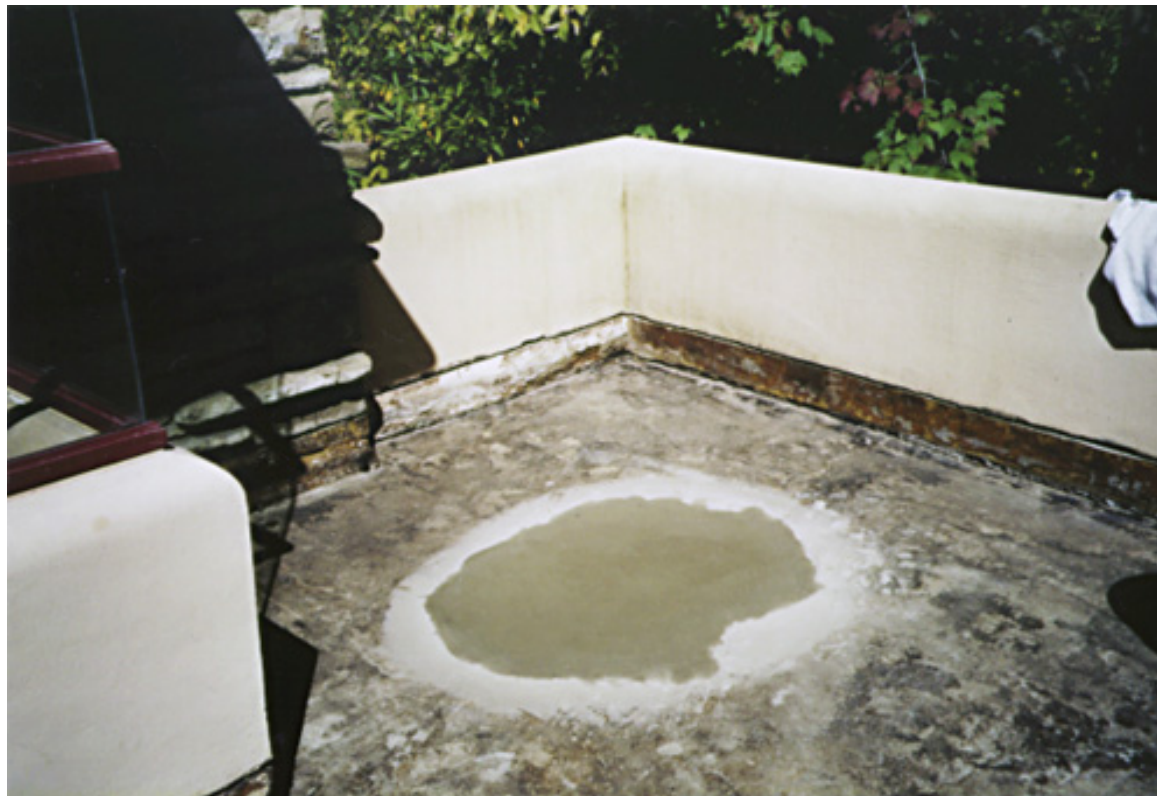
Some of the concrete decks required patching before the new terrace water proofing system could be applied.

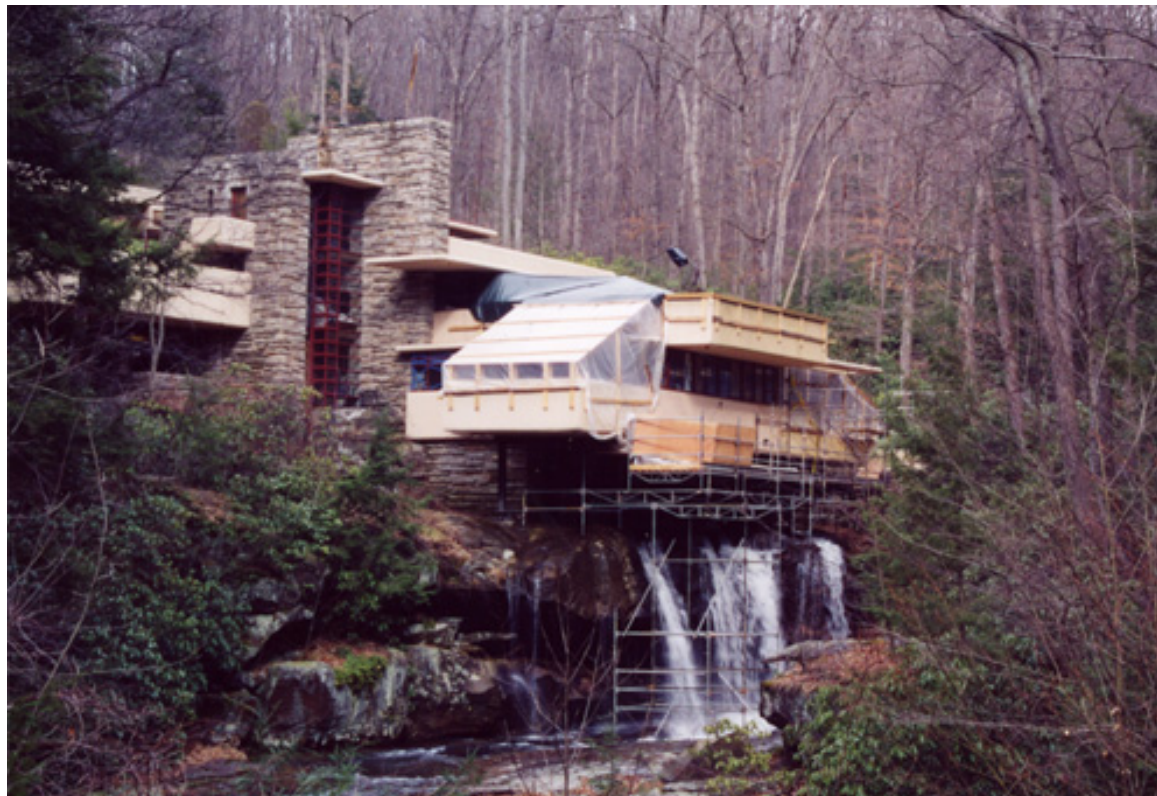
During the winter months the terrace areas were tented to protect the exposed concrete decks from the weather.

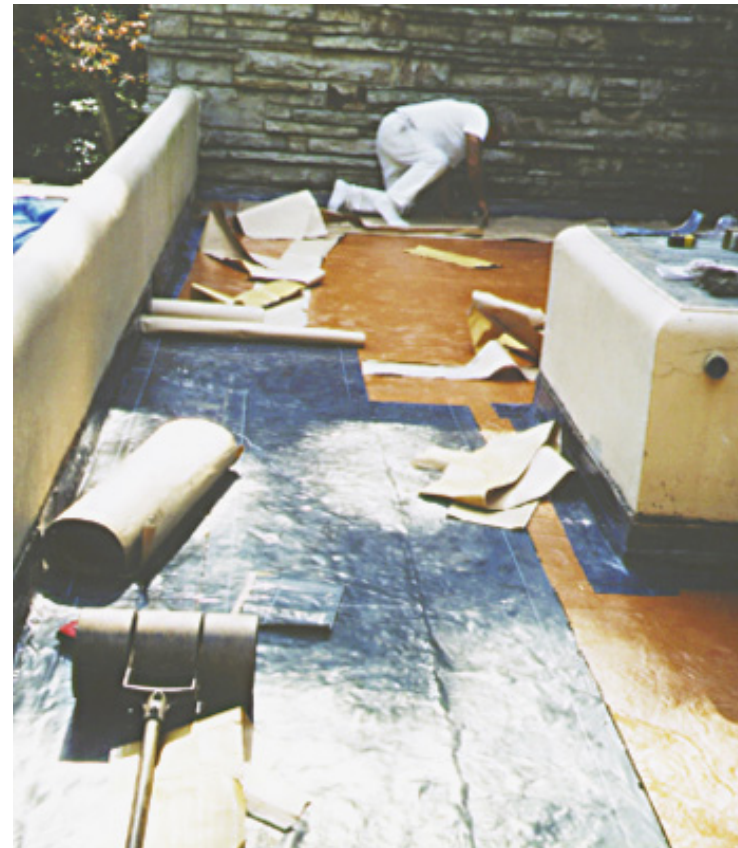
1. A two-part, self-curing liquid membrane is applied where the terrace deck meets the wall to form an angled cant. This cant helps to relieve stress between the horizontal and vertical joints and creates a thermal break.
2. A two-part, self-curing, rubber-based material is then fluid applied over the deck to create a protective membrane.
3. Once this membrane has set, two plies of self-adhering, modified-asphalt membrane are laid shingle fashion. Two plies are also installed at the flashing and the top edge is sealed with two plies of liquid membrane.

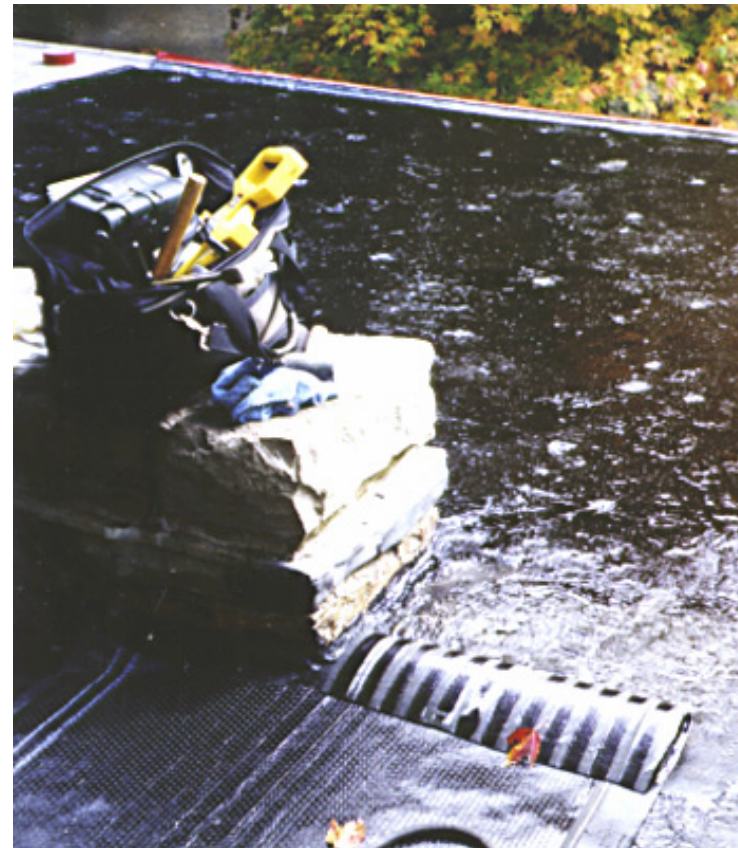
4. A ¼" drainage mat is then laid on top of the membrane. This drainage mat protects the membranes below and directs water to the drains. This mat is thinner than the drainage mat initially used on the Herb Terrace and is covered with an open monofilament woven filter fabric. This fabric has a greater tensile strength than the filter fabric on the original drainage mat (250 lbs vs. 90 lbs) and will not give under pressure, eliminating the trampoline effect. Its permeability is 100 gallons/sq. ft./min., which is twice that of the setting bed and well above what any downpour could dump on the terraces.

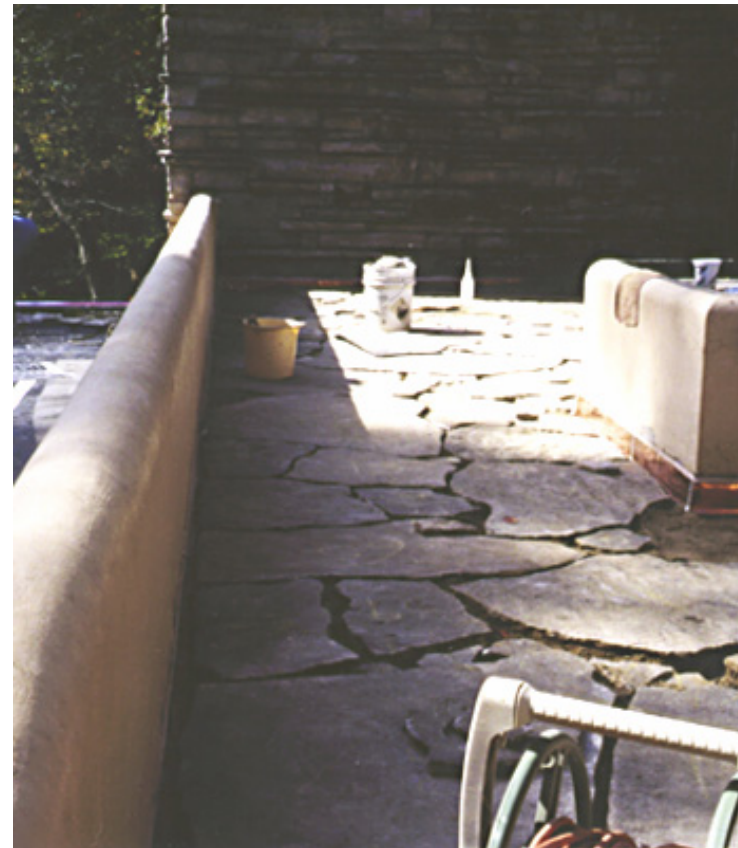
5. The next layer is the setting bed (1 part Portland cement to 10 parts sand). The first good rain dampens the cement and solidifies the sand so that the bed does not shift. The amount of cement used does not significantly alter the permeability of the sand bed, and is not enough to "glue" down the flagstones.
6. The paving stones are then laid in the setting bed over top of the waterproofing system. The joints are mortared with a mix of 1 part cement to 3 parts sand.
7. Finally, copper flashing is positioned between the vertical walls and the paving stones.

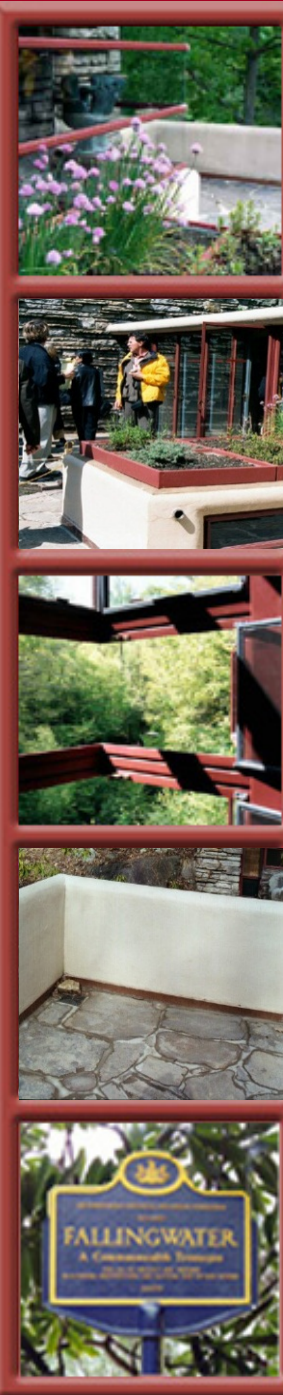
This detail shows the recommended reconstruction of the terraces. New wood sleepers were used to raise the 1/2" plywood deck above the concrete.

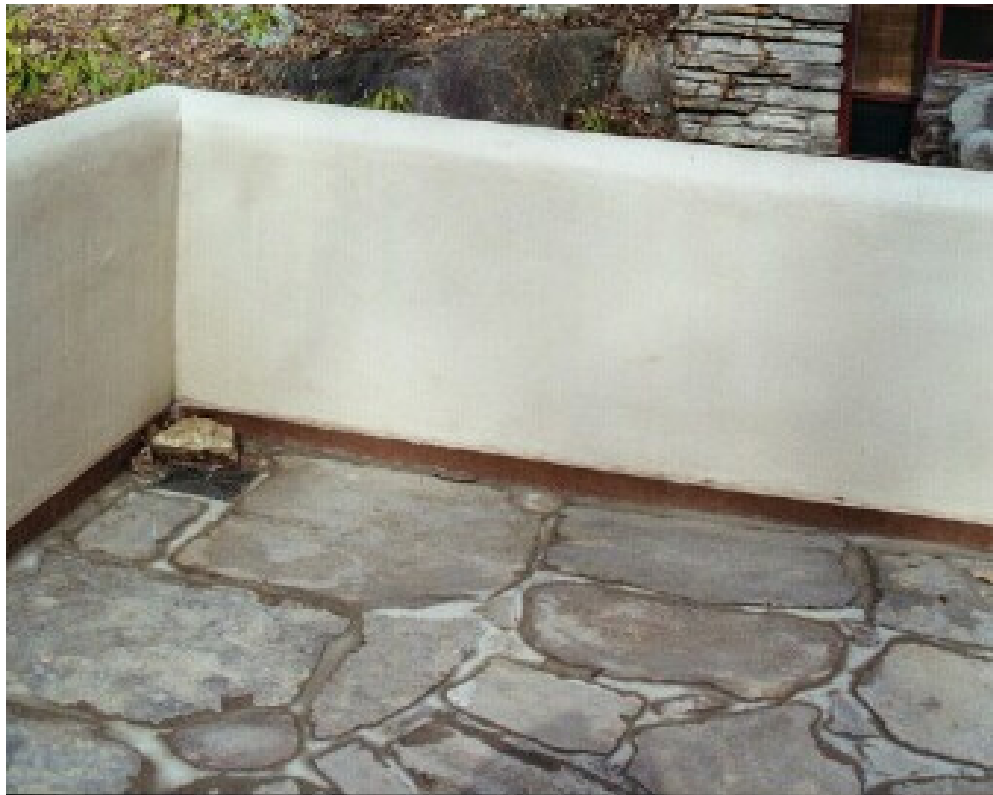
This image shows one of the finished reconstructed terraces, with new drains, copper flashing, and grouted flagstone.

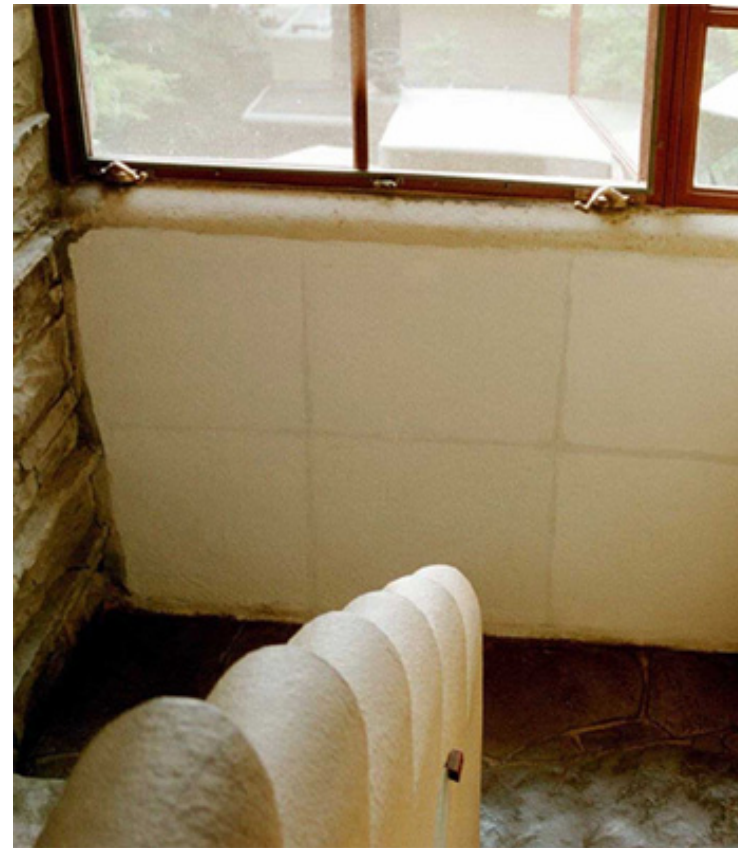
- The concrete construction further complicated matters, because the added moisture affects adhesion. Another aspect to be considered was durability: Fallingwater hosts over 140,000 visitors annually.
- The building team experimented with paint and coating products to determine the most effective way of achieving building envelope durability and breathability along with interior presentation.
- Once a system was selected, field and lab tests were conducted to verify performance. Micrographs were used to study the existing paint and system compatibility.

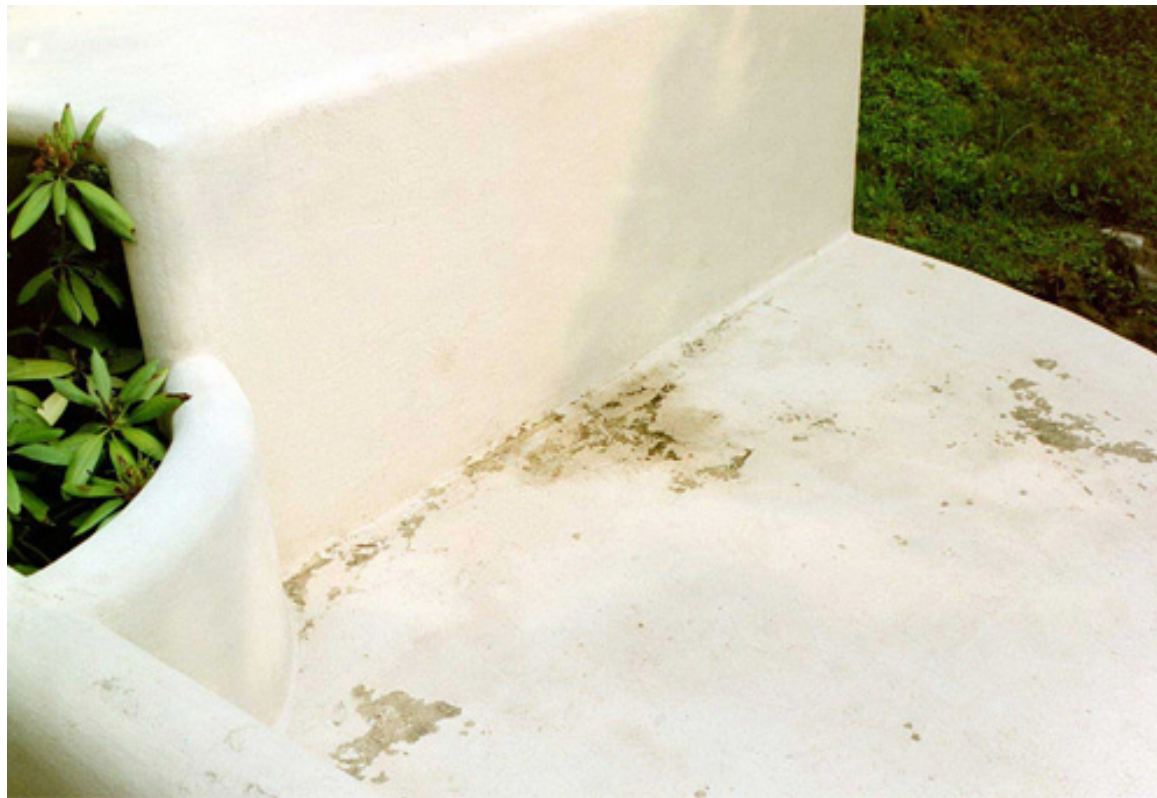
The area where the overhead canopy meets the roof deck of the main house is showing signs of delamination, efflorescence, and microbial growth.

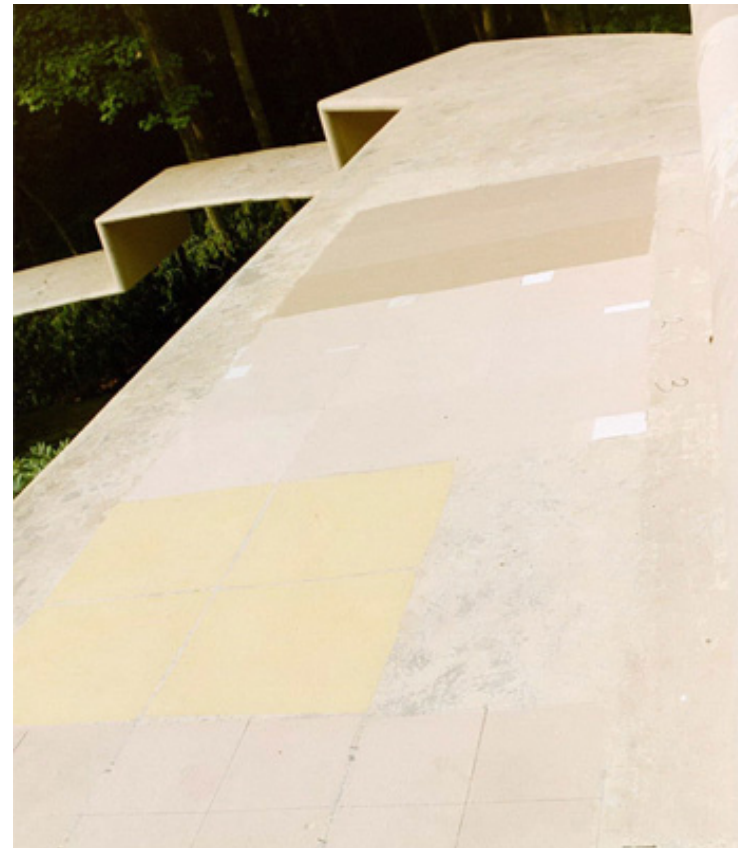
- Testing was conducted on the guest house canopy, facing south, and included parapets and other horizontal surfaces.
- Surfaces were pressure washed and two coats of silicate-based paint were applied. Both coats were diluted with approximately 15% water and the second coat was applied about two hours after the first.
- Silicate-based paint consists of a combination of silicone resin and a special water-soluble alkali silicate. The silicate acts as a binding agent, providing a breathable, yet water repellent coating.

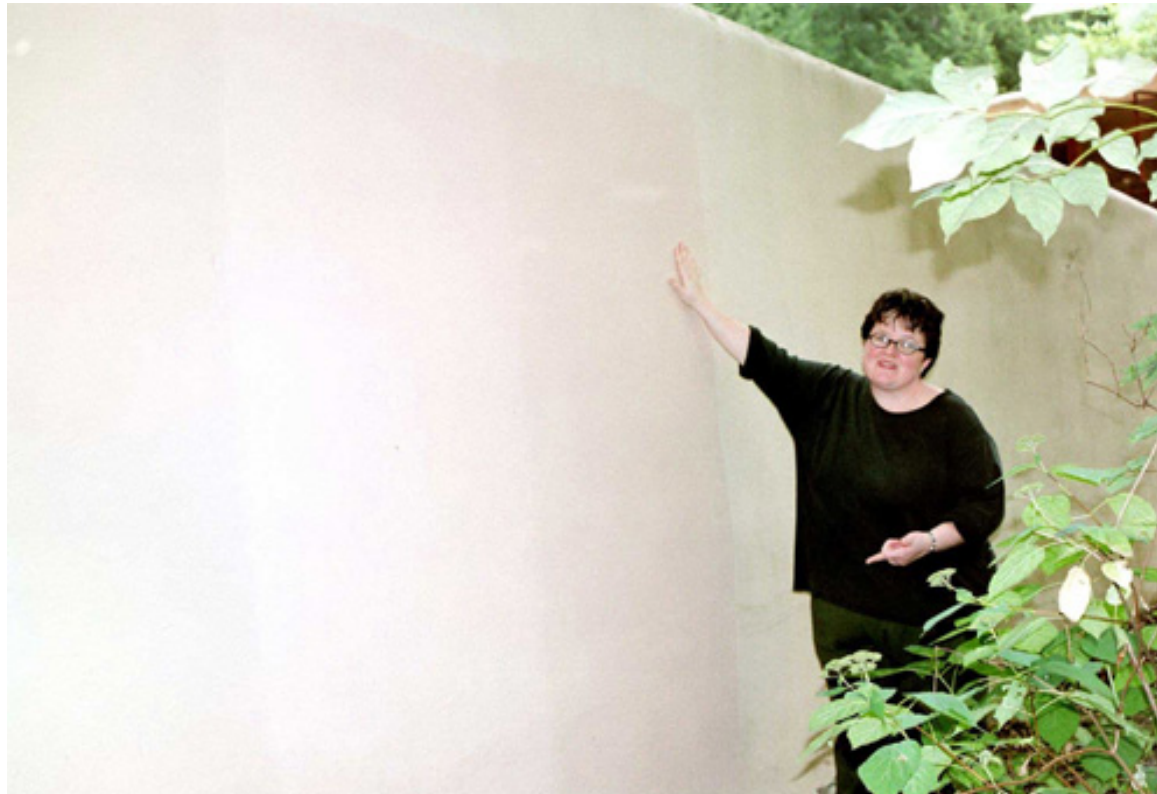
Exterior vertical surfaces, such as walls and parapets, also required restoration. Various paint test samples were exposed to the effects of all four seasons.

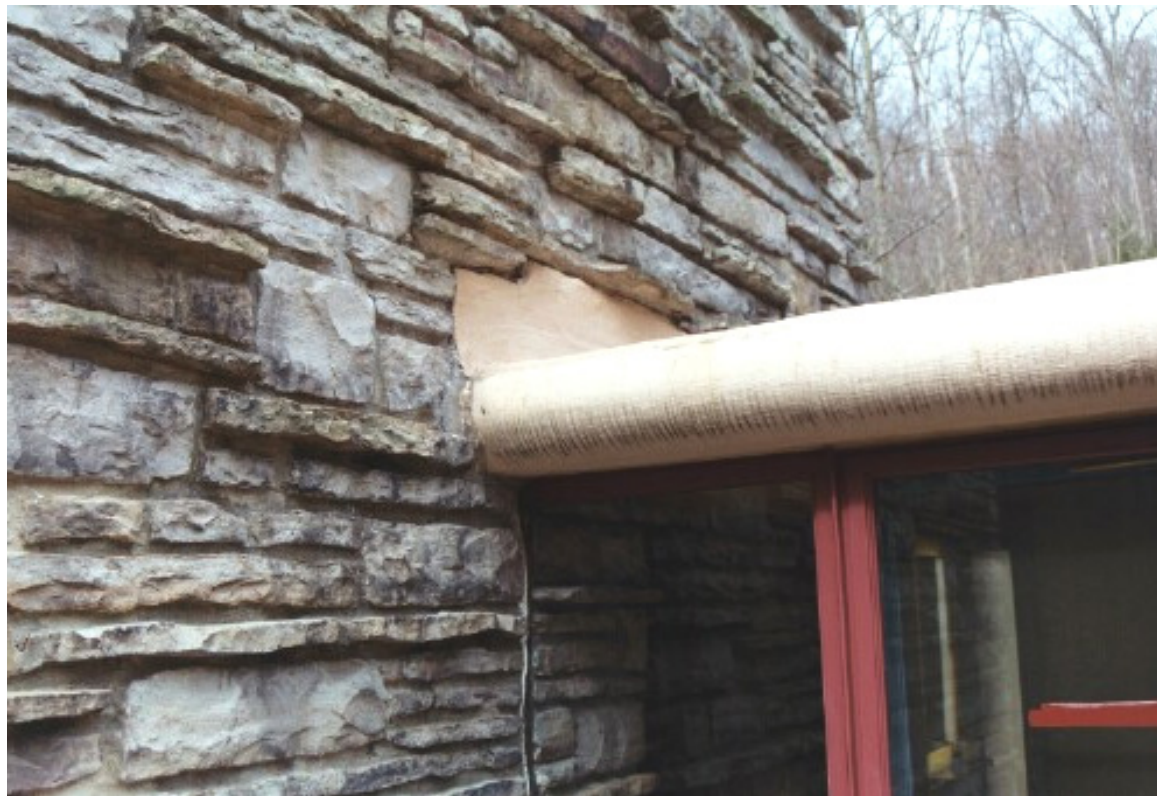
In addition to the exterior plaster surfaces, the exterior stone work also required repointing in some areas and application of a water repellent coating.

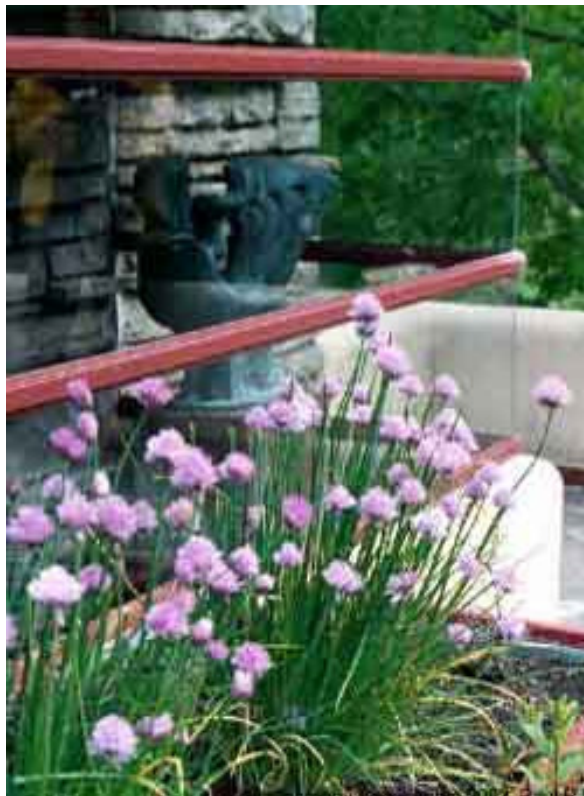
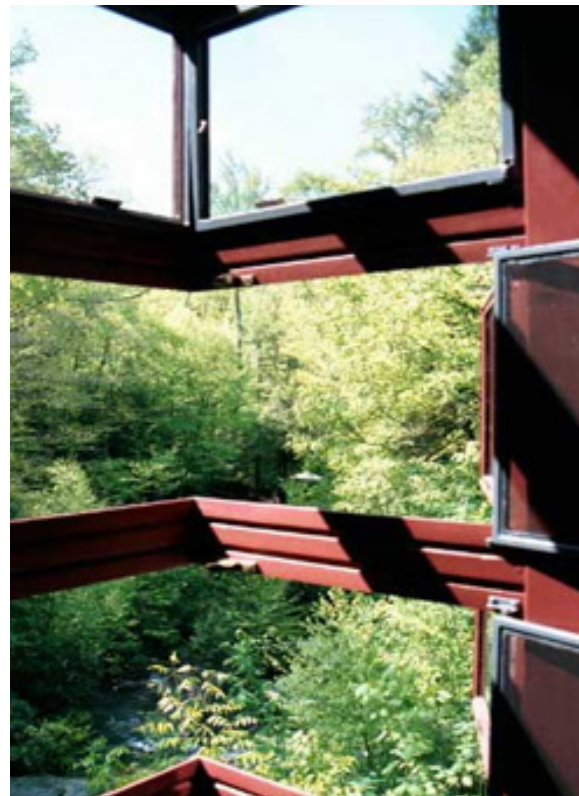
Another area in the research review revealed extensive restoration needs concerning the steel windows and doors of Fallingwater.

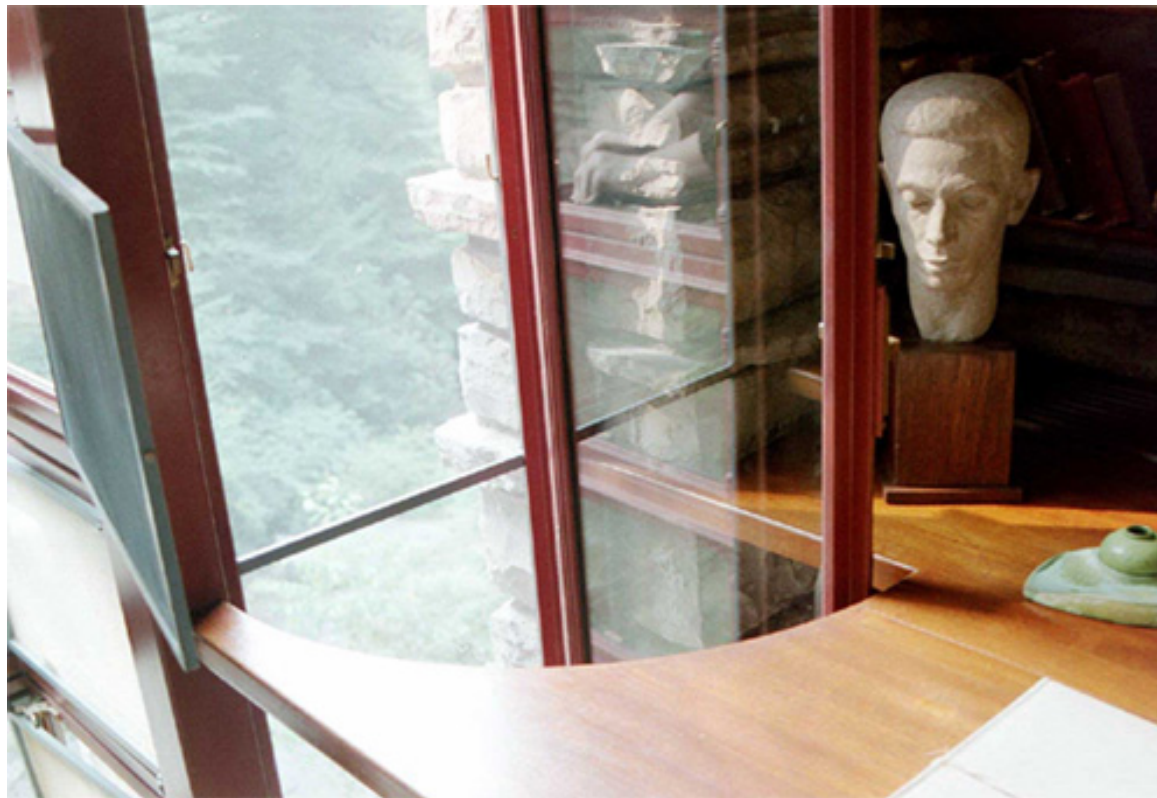
In 1988, the original glass in Fallingwater was replaced with a special UV-filtered glass to block out harmful UV rays and help preserve interior materials.

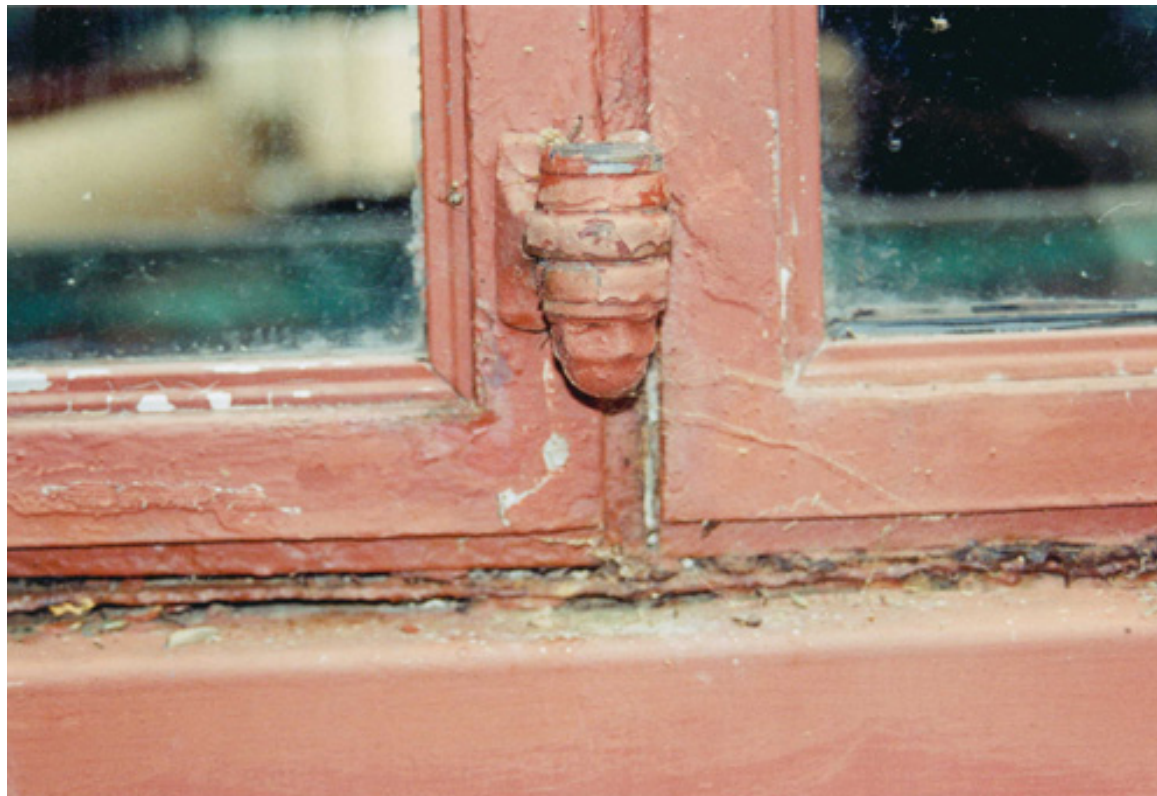
A local window contractor was hired to adjust and service each operable window sash and door for proper operation.

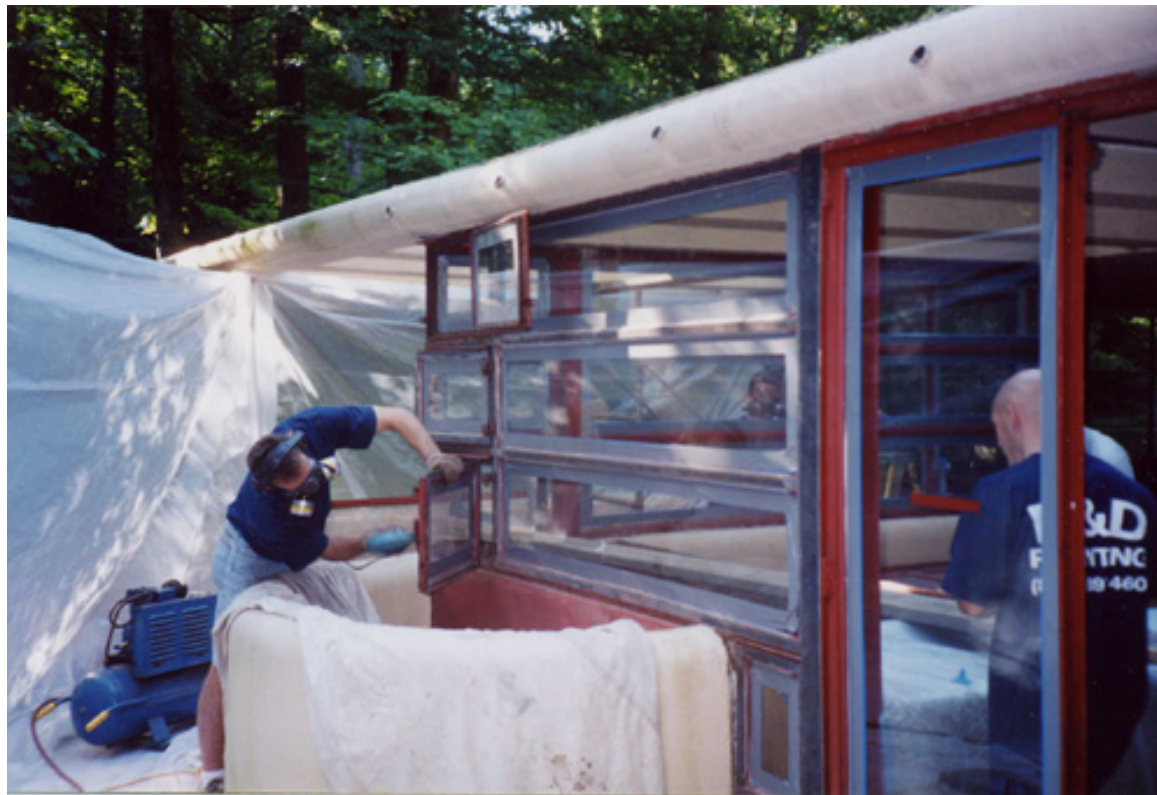
This involved stripping 60 years worth of accumulated paint and caulk followed by recaulking and painting with Fallingwater's signature Cherokee Red.

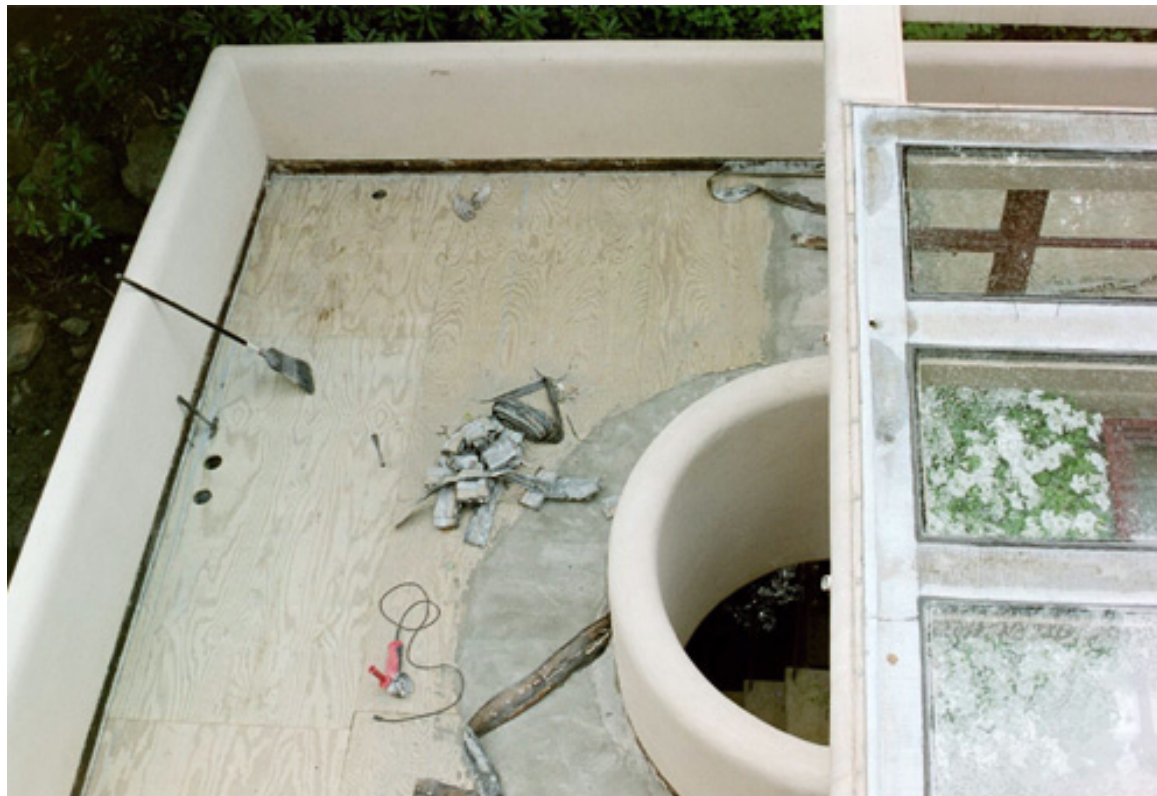
Skylights represented another source of moisture penetration, which required extensive repair and restoration.
